# 1. Introduction

## Ardmore Historic Commercial District Design Guidelines

### Purpose

The “Ardmore Historic Commercial District Design Guidelines” (the “Guidelines”) is an illustrated guide to assist with decisions regarding design, material, or external appearance changes to historic resources within the Ardmore Downtown Historic Business District, hereinafter referred to as the “District.”

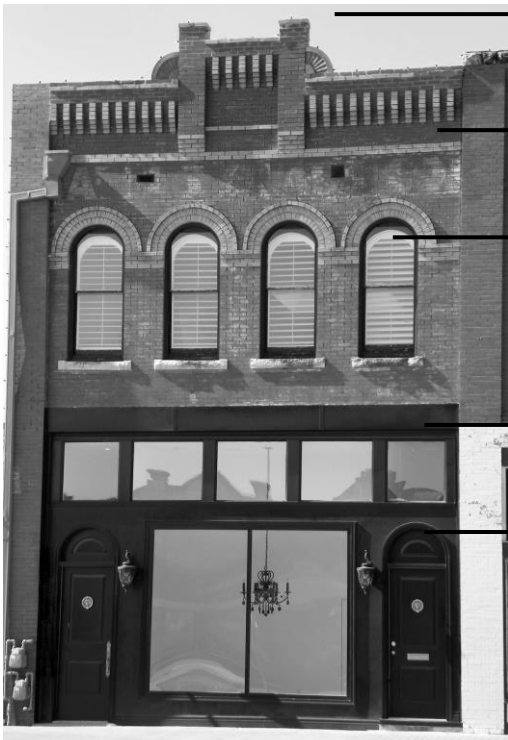
118 East Main, "after" photo

Decorative masonry at parapet is repaired. Missing ornamental stone at parapet cap is replicated.

Windows are repaired and repainted.

Non-historic clerestory removed and replaced to closely match proportions of historic clerestory.

Non-historic pedestrian and garage doors removed and replaced with contemporary but compatible pedestrian doors and storefront.

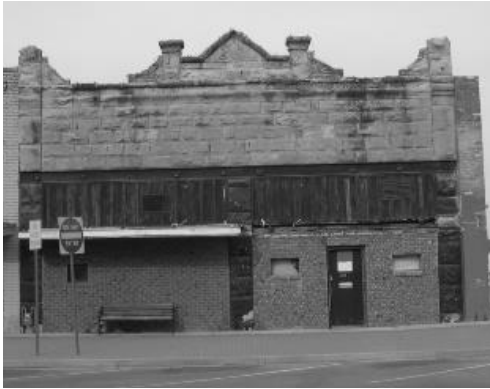
**Before: Masonry and Wood Siding Infill in Traditional Locations for Glazed Clerestory and Storefront**

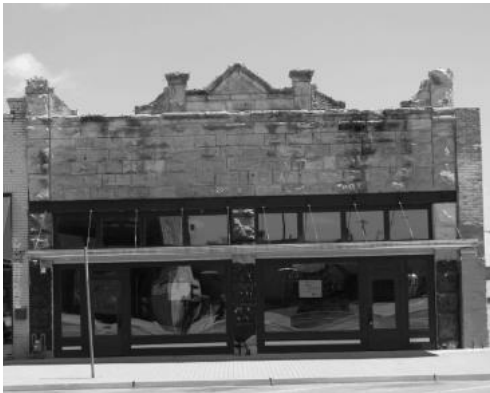
**After:**

- 1. Infill removed to expose clerestory.**
- 2. Masonry infill removed and replaced with glazed storefront compatible with building.**
- 3. Flat canopy rebuilt in location consistent with historic structure.**

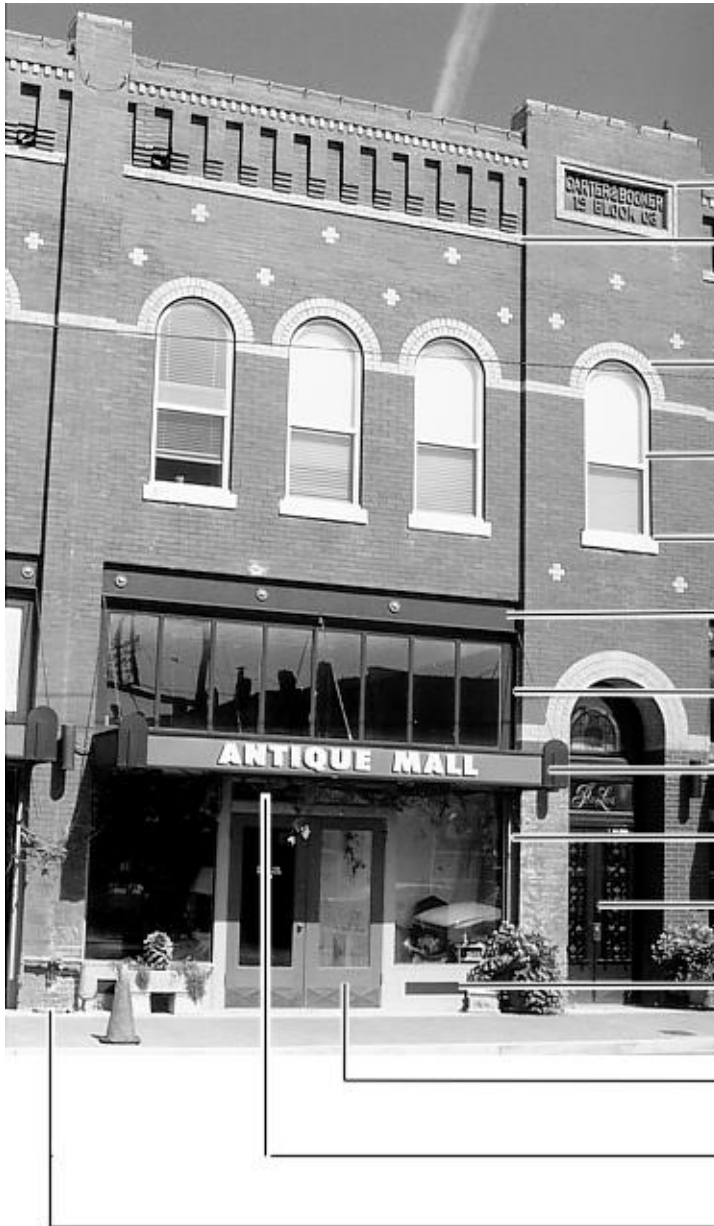
## BASIC COMMERCIAL BUILDING FRONT COMPONENTS

Sign Panel: Centered vertically in masonry element.

Foundation: Horizontal band between floor and ground lines, usually masonry

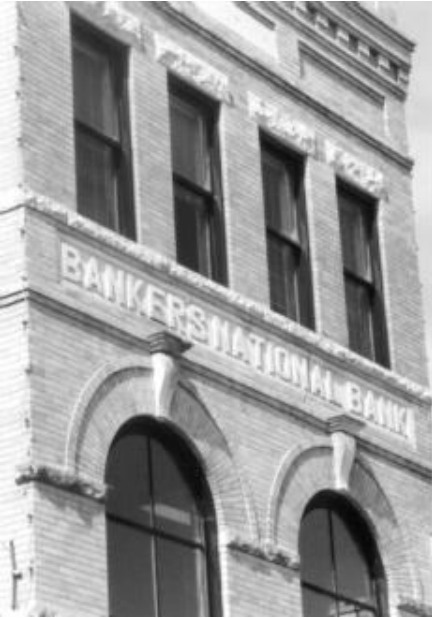
**Brick Arches, Corbelled Cornice and Banding. Stone Lintels, Keys, Sills and Sign**

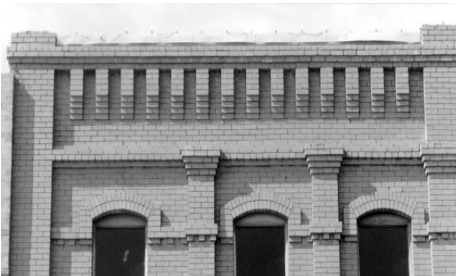
**Brick Cornice and Articulated Segmental Arched Windows**

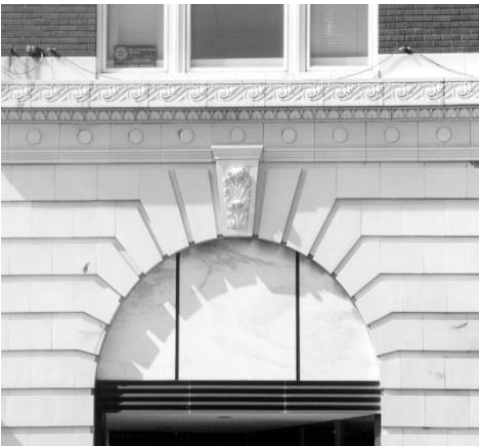
**Rusticated Cast Stone Arch**

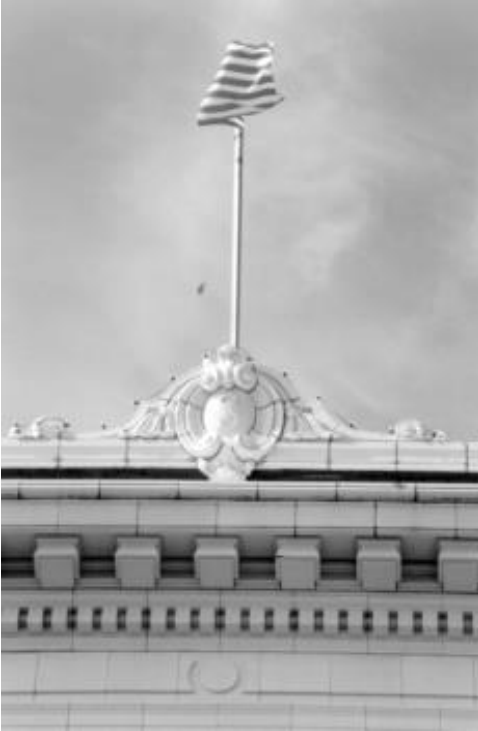
**Glazed Cast Stone Cornice**

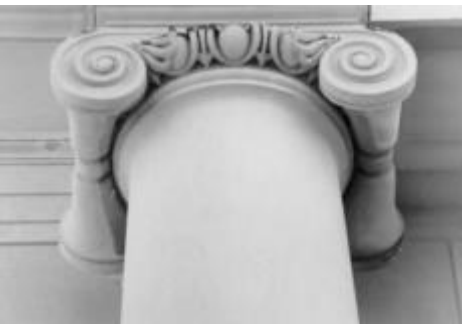
**Cast Stone Column**

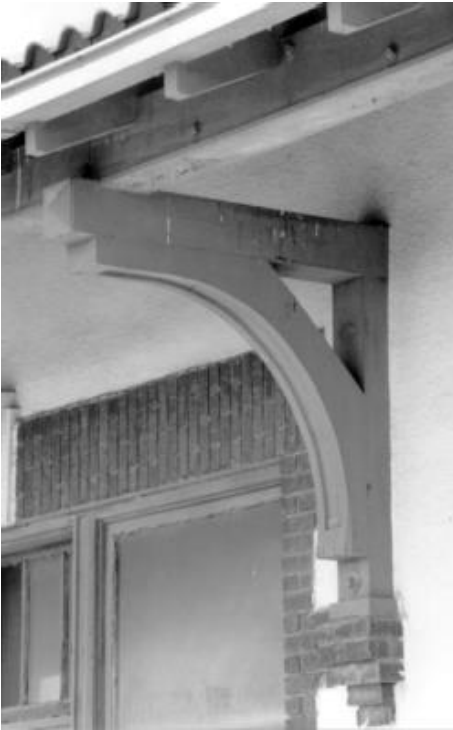
**Exposed Rafters and  
Wood Bracket**

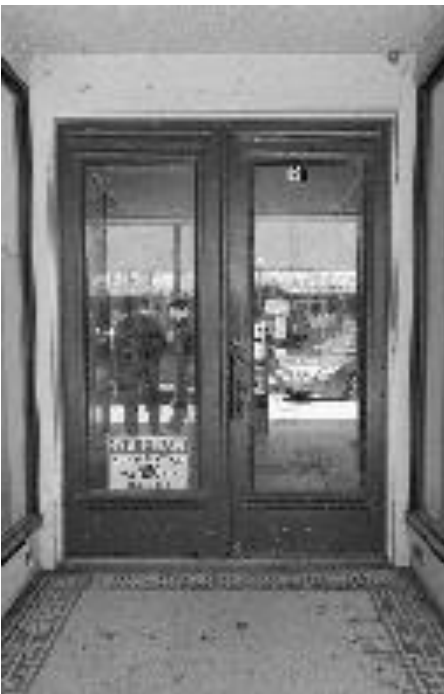
**Wood Stile & Rail Doors  
with Original Mouldings**

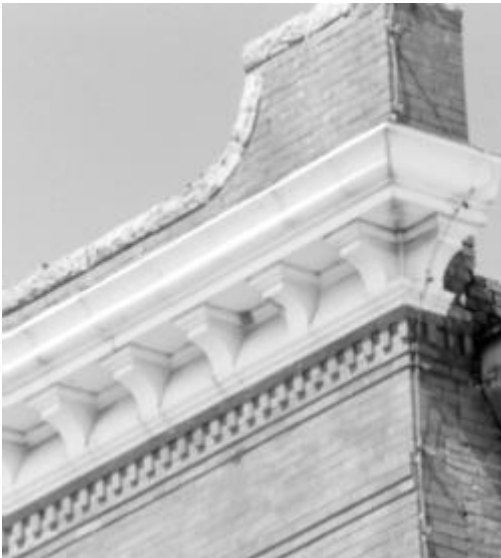
**Ornamental Metal Cornice**

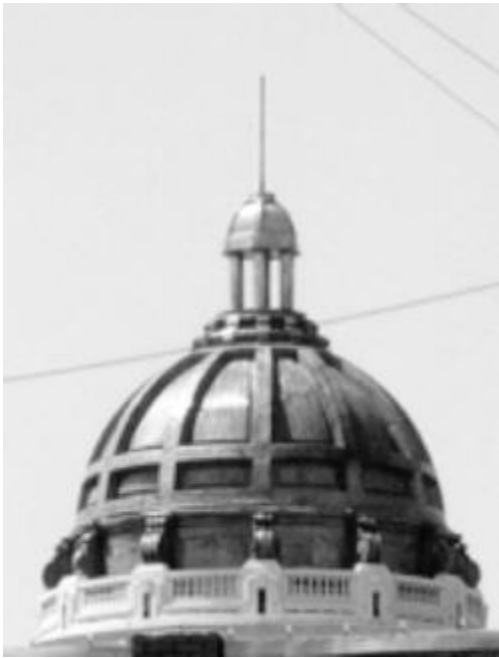
**Metal Roofing of Dome**

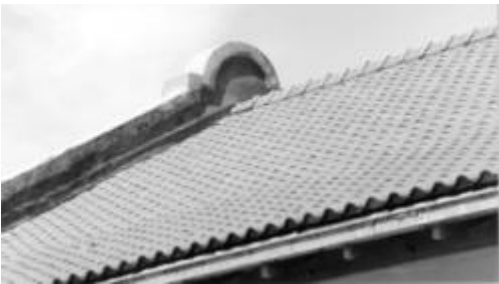
**Tile Roof and Parapet Flashing with Exposed Cap**

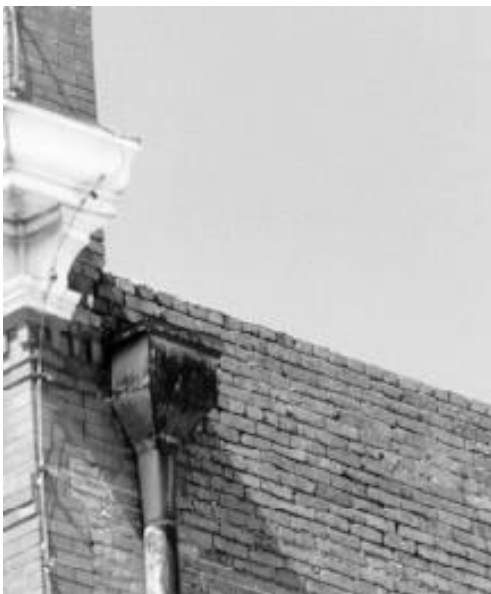
**Parapet and Downspout**

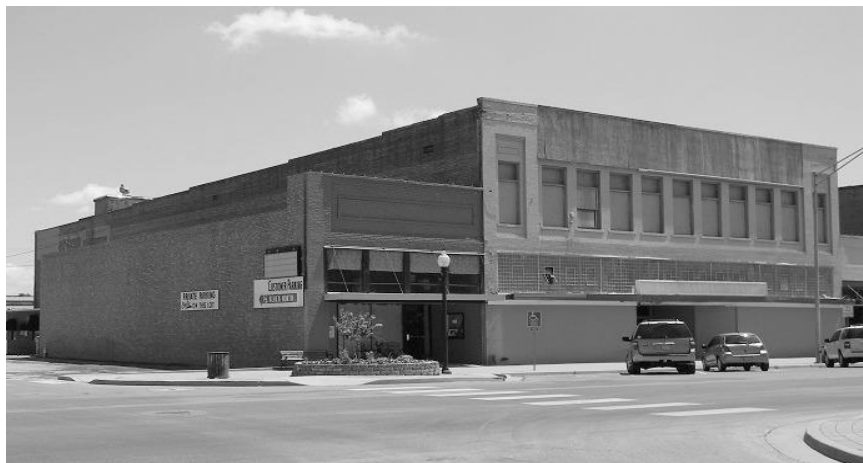
**Stepped Parapet at Two Story Building Indicating Roof Slope**

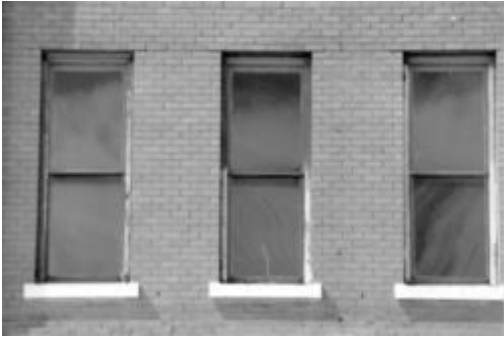
**Rectangular, Fully Glazed Hung Wood Sash**

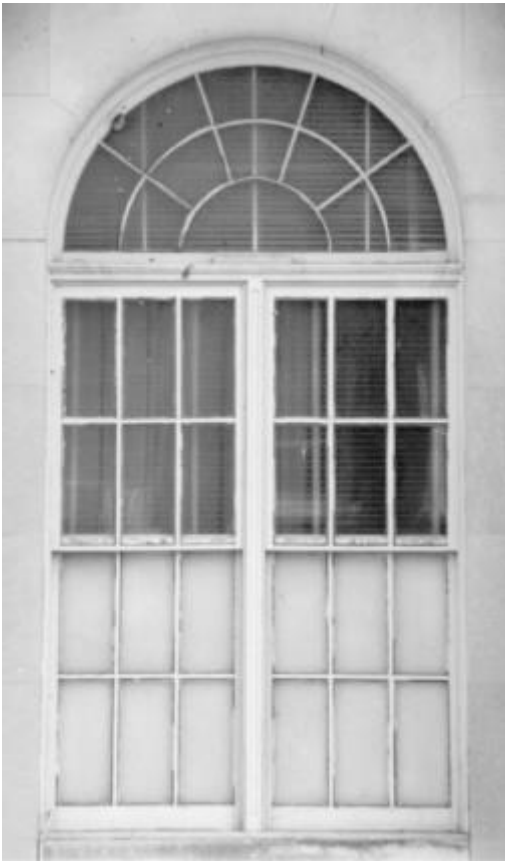
**Divided Light Round Arch over Hung Wood Sash, 6 over 6**

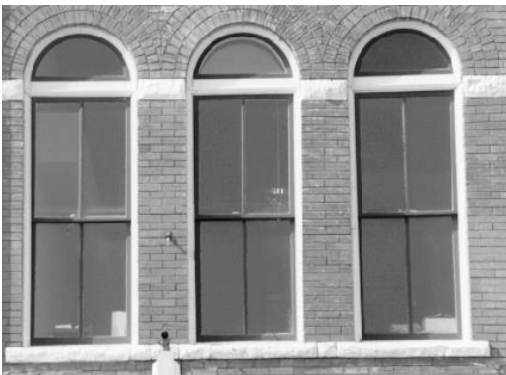
**Round Arch, Fully Glazed over Hung Wood Sash, 2 over 2**

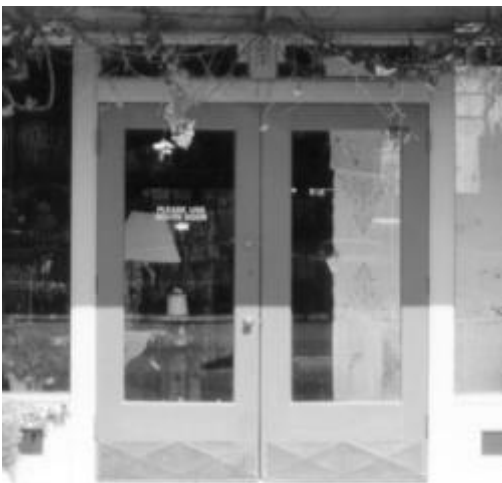
**Glazed Doors and Transom**

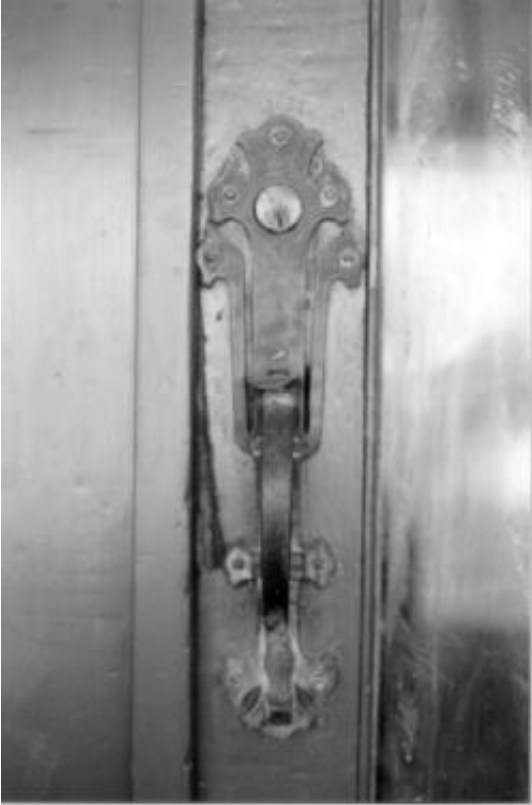
**Historic Door and Hardware**

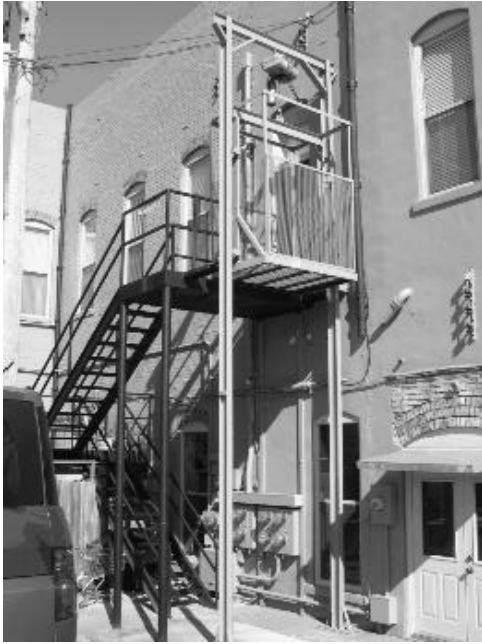
**New Upper Level Back Entry Leaves Pedestrian Alley Access**

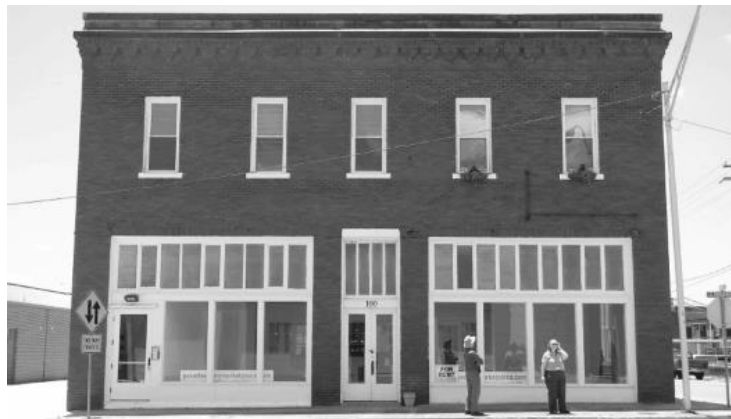
**Below Right: Repaired Storefront with Integrated Front Upper Level Access**

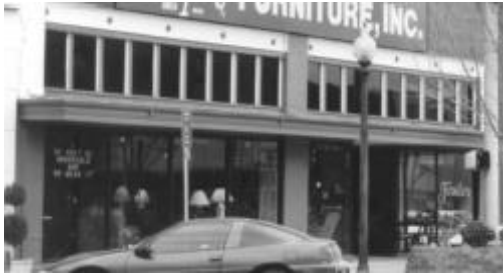
**Wood Storefront with Canopy and Clerestory**

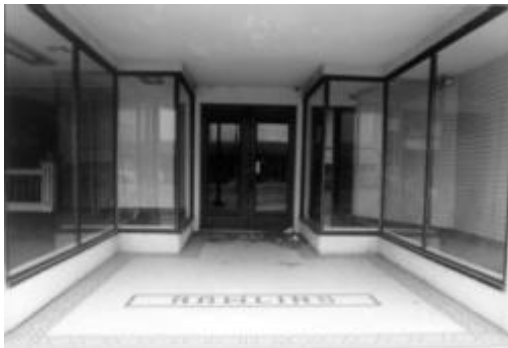
**Recessed Bronze Storefront with Lettering in Mosaic Tile Floor**

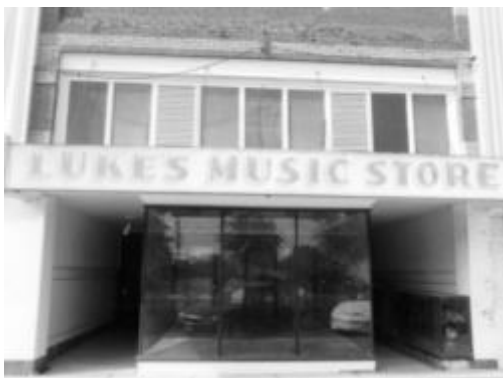
**Recessed Bronze Storefront with Center Show Case**

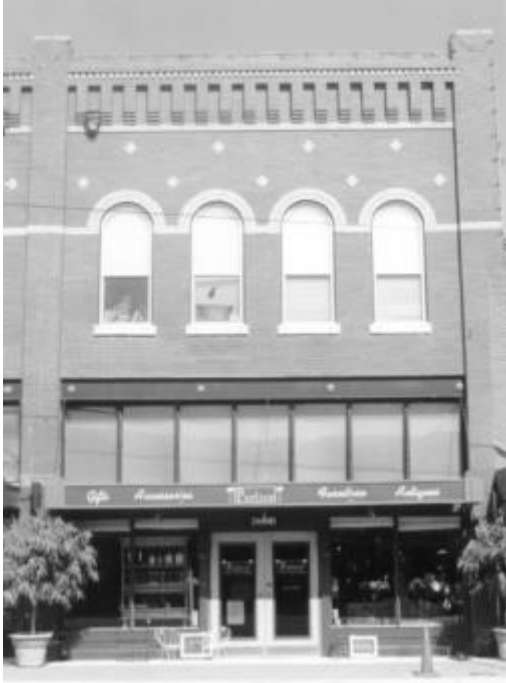
**Symmetrical Wood Storefront**

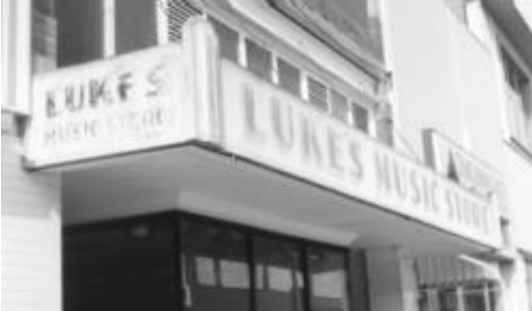
**Historic Canopy and Sign**

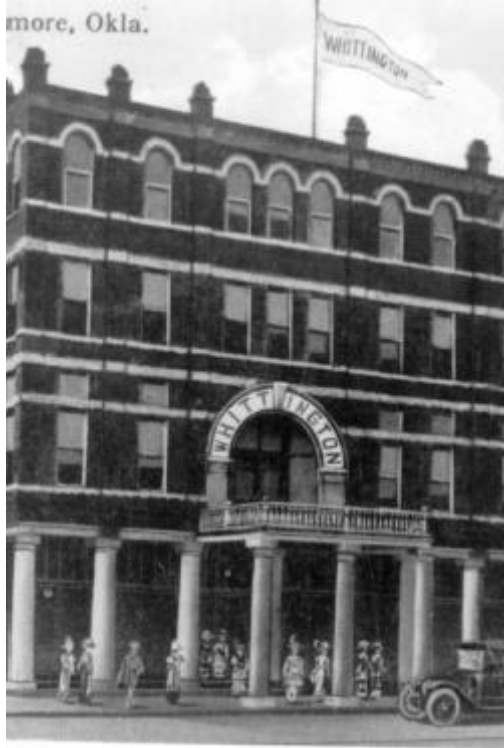
**Stone Columns and Arch of the Historic Whittington Hotel, built 1886, destroyed 1915**

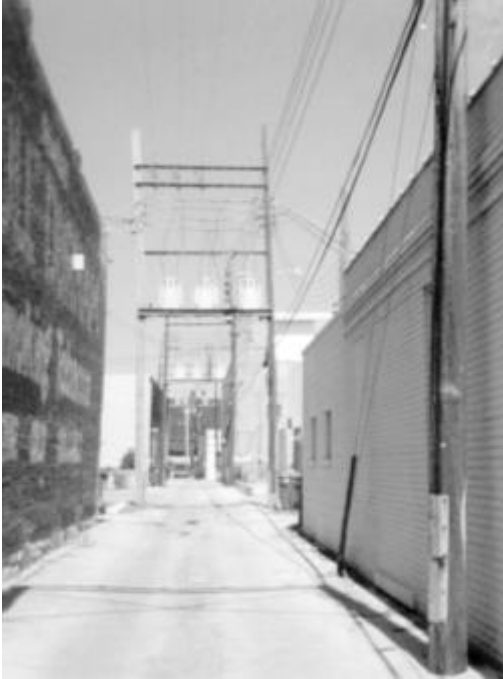
**Utilities Confined to Alley**

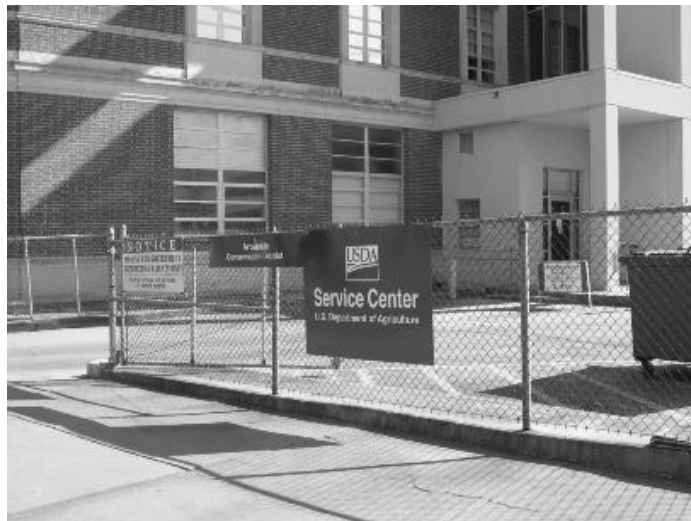
**Dumpster behind Building  
in Secure Enclosure**

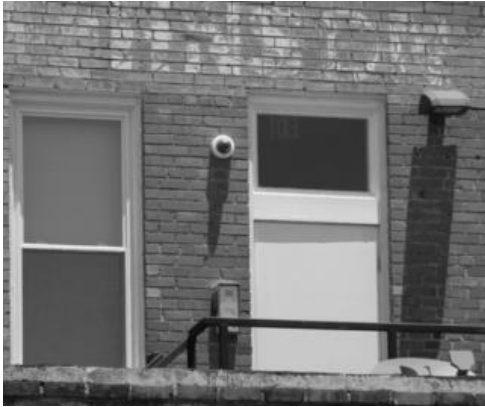
**Security and Lighting at Back Entry**

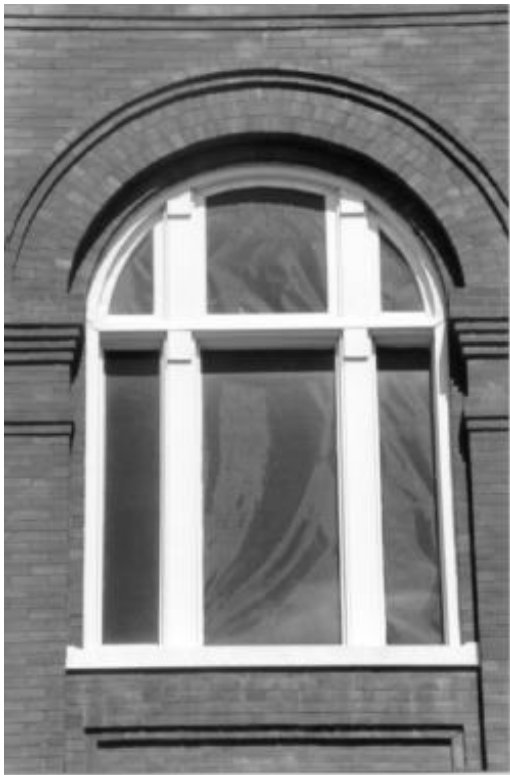
**Arch with Fixed Infill Glazing**

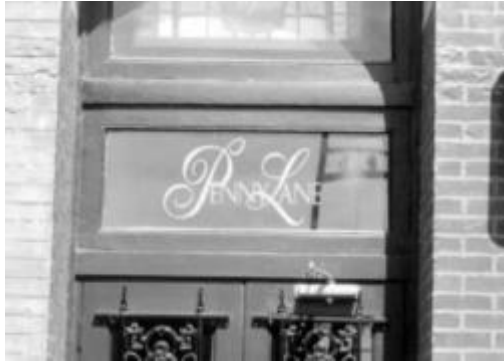
**Wall Sign Hand Leafed on Transom Glass**

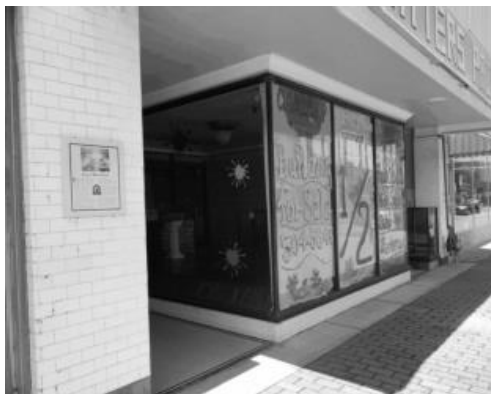
**Uncover an Opportunity: Paper Hides an Outstanding Storefront**
